SAFETY ALERT BULLETIN

NUMBERS: SB 17-08
 STATION: ALL
 INCIDENT DATE: Multiple

Aircraft Cargo Compartment 2” Ceiling Gap

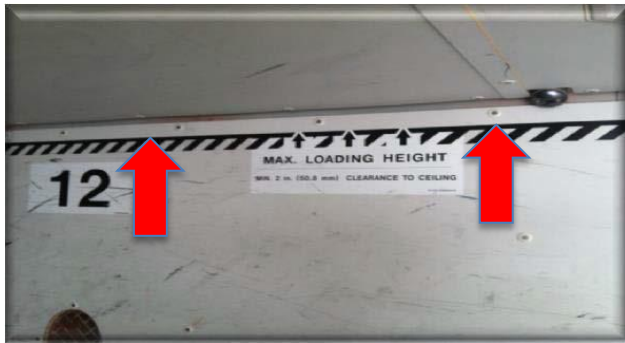
E190, Airbus Aircraft, Regional ERJ 175 :

Recent audits of cargo bins throughout the network have shown bags, freight, and mail are being loaded above the fire suppression placards or within 2 inches of the ceiling. It is imperative that bags, freight, and mail are not loaded within 2 inches of the cargo compartment ceiling to ensure the fire detection and suppression system work accordingly.

Baggage and/or cargo must not be loaded above the 2” ceiling Bin Gap marking around the sidewall.
