AIRCRAFT DAMAGE ALERT BULLETIN

NUMBER: DA16-30

GPU Power Cord Damages Panel Door and Receptacle Pins

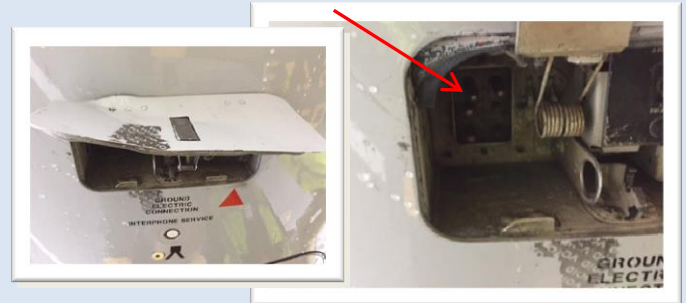
A fleet service agent was repositioning a pushback tractor and towbar to another gate when the towbar caught the GPU power cord and pulled it from its receptacle on an A319.

NEVER operate equipment around aircraft without being situationally aware of your surroundings!

Section 12-5-8 – D. 2-N. Before backing, make a “walk-around” to be sure the path is clear. In a congested area, use a guide, since another vehicle or a person could enter the area after the walk around.

Section 12-5-11 – A. While driving or approaching an aircraft, if there is any doubt about clearance, get a guide. Proceed only when there is a continuous standard hand signal to do so. Stop if visual contact is lost or there is any doubt.

Section 8-1-3 – Q. It is the operator’s responsibility to ensure there is adequate clearance prior to operating or towing any piece of equipment. If in doubt, the operator must request a guideperson.
