AIRCRAFT DAMAGE ALERT BULLETIN

NUMBER: DA16-32

Safety Alerts are a publication of American Airlines Corporate Safety.
For questions or comments, please contact your Hub or Regional Corporate Safety Manager.

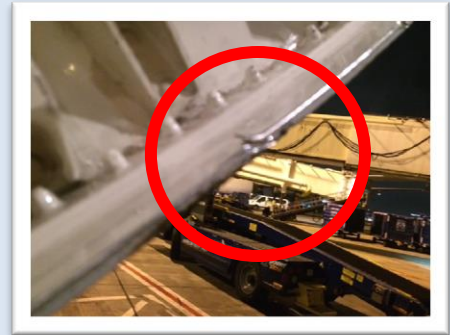
Cargo Door Sill Damage

STATION: LAX
INCIDENT DATE: Dec. 12, 2016

While loading a B737 aircraft, a baggage cart made contact with the beltloader causing the beltloader to strike the forward area of the cargo door sill. The impact caused the forward fuselage to raise approximately 5”.

ALWAYS maintain situational awareness when driving near the aircraft!

Section 8-1-3 – Q. It is the operator’s responsibility to ensure there is adequate clearance prior to operating or towing any piece of equipment. If in doubt, the operator must request a guideperson.

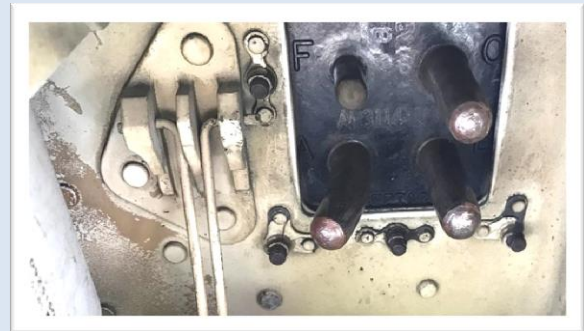
Damage to GPU Receptacle Prong

STATION: BUF
INCIDENT DATE: Dec. 17, 2016

After obtaining permission to disconnect ground power from flight crew on an A319 aircraft, employee shut off power and began to retract cord, without disconnecting from the aircraft first.

ALWAYS maintain situational awareness!

Section 12-6-3 – A. All AA employees are responsible for being aware of conditions that are unsafe and/or have the potential for causing accidents/injuries.

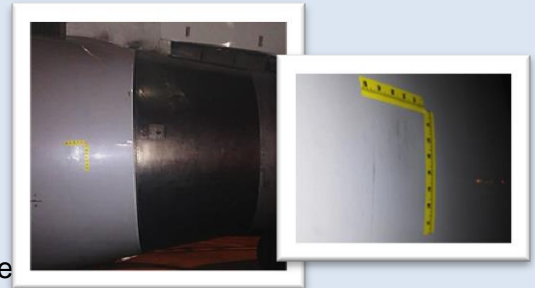
Damage to #1 Engine

STATION: PHL
INCIDENT DATE: Dec. 18, 2016

Baggage cart struck the #1 engine of a B757 after disconnecting from tug. The pin on the tug was bent and agent assumed that the baggage cart was secure after he failed to disconnect the baggage cart from the tug moments earlier.

NEVER use equipment that is unsafe or malfunctioning!

Section 8-1-3 – D. Unsafe or malfunctioning ground equipment shall not be operated. It is the responsibility of the operator to ensure ground equipment is in a safe operating condition before use. (Check: brakes, hood, door, hood/door latches, seat stability, glass, steering, tires, hitches, horn, etc.)

Section 8-1-3 – I. Ensure all carts and ULDs are fully secured before transporting. Ensure all bag cart and ULD curtains are closed and secured, ULD's dolly locks are engaged, and the towbar is securely attached prior to towing.

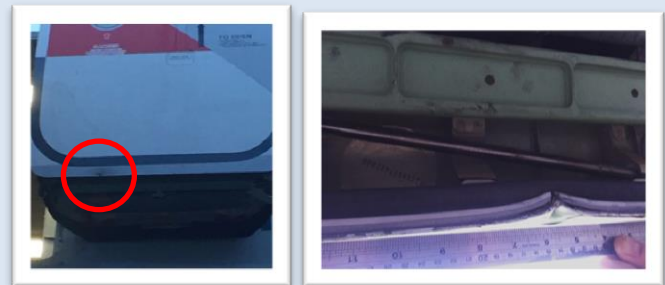
Damage to R4 Door

STATION: PHL
INCIDENT DATE: Dec. 18, 2016

Found on arrival in DUB, R4 door was struck.

ALWAYS report aircraft damage to your Manager!

7-2-6 – C. Each employee is required to notify their Manager or Supervisor and the local AA Tower or Operations for any safety-related event. Timely and accurate reporting of aircraft accidents and incidents is critical to ensure an effective response.

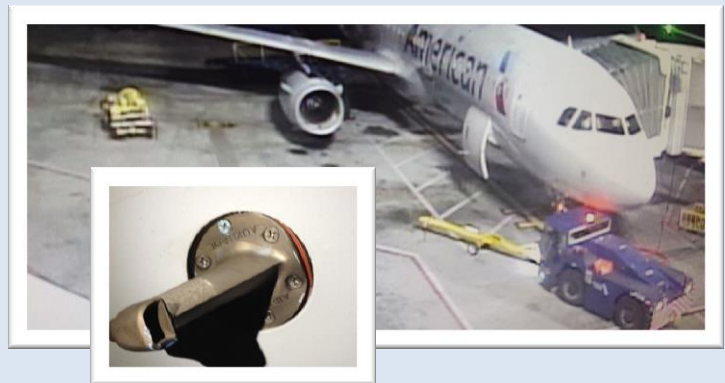
Pushback struck TAT Probe

STATION: CLT

INCIDENT DATE: Dec. 27, 2016

While repositioning pushback tug at the gate with towbar still attached to the front, pushback made contact with the A321 damaging the TAT probe.

ALWAYS maintain five feet clearance from the aircraft and NEVER drive with the towbar only attached to the front.

Section 8-1-1 – A. Each employee operator of company owned ground equipment is responsible for the safe operation of that equipment. (5) Maintain a minimum clearance of five (5) feet between the aircraft, except for those designed to directly interface with the aircraft, such as lavatory trucks.

Section 9-7-6. Caution: Towbars may never be pushed alone in front of a tractor. This may result in jackknifing of the towbar and potential damage to the towbar and tractor. Towbars may be towed behind path of the pushback tractor on either the front or rear hitch.
