DO NOT LOAD BAGGAGE AND CARGO **ABOVE THE STRIPED LINE!**

Recent FAA inspections have shown that baggage continues to be loaded above the placarded line in cargo bins of the ERJ170/175 aircraft.

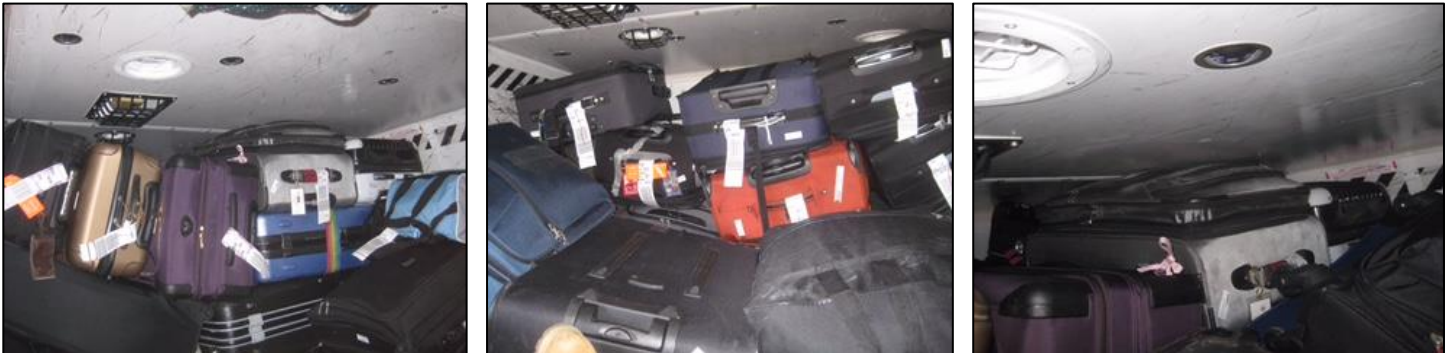
Placarded lines (as shown below) circle both cargo bins to indicate loading limits inside the cargo bin and are designed for passenger and flight crew safety in the event of a fire. Fire extinguisher nozzles in the ceiling of the cargo bin cannot function effectively if baggage or cargo is loaded above the placarded line. The fire suppression system must have the 2-inch gap to effectively spread the extinguishing agent throughout the cargo bin.

THIS IS UNACCEPTABLE AND MUST STOP IMMEDIATELY.
