Safety Alert

2017 - 01

ERJ-175 Waste Container

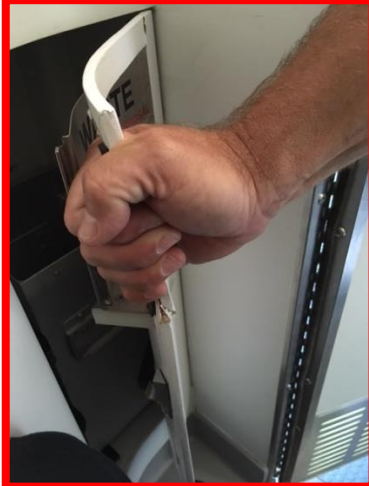
Do not open the door by grabbing the edge of the panel and opening the door; this causes the panel to break over time. This is a non-differable item and will cause the aircraft to be placed out of service.

Incorrect Method of Opening

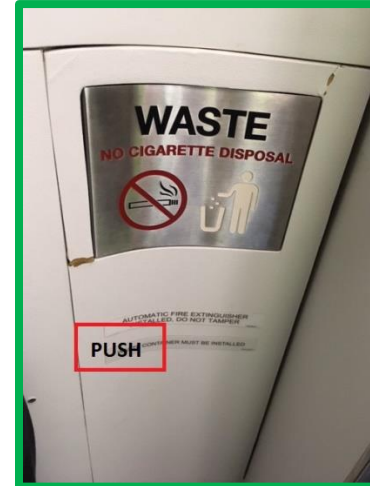
There has been an increased number in interior aircraft damages to the ERJ-175. These have been caused by the improper opening of the galley waste container door. The door is designed to be opened by pushing below the metal flip door and the door will release open.

Correct Method of Opening
