# SAFETY ALERT BULLETIN

NUMBERS: SB17-02

## Damage Due to GPU Pull Away Regional Aircraft

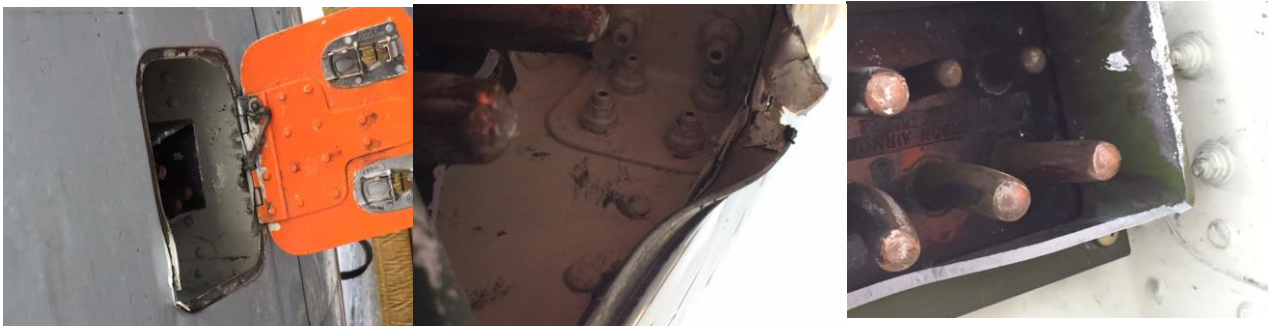
A CRJ-200 was damaged recently when the GPU was pulled away without being disconnected from the aircraft. Let's review the proper steps for shutting down ground equipment and avoiding a 3-way connection:

- Shut down the ground equipment.
- Remove the cord/hose from the aircraft and close the panel door. **(Double tap the door to ensure it is fully closed and secure.)**
- Stow the cord/hose on the unit and ensure it is secured.
- Complete the 360° walk around of the unit. It is the responsibility of the tug driver to complete a 360° walk around to ensure that all cables and hoses from any ground equipment are disconnected from the aircraft before connecting the ground equipment to the tug and driving away from the aircraft. This will allow the tug operator to clearly see that a three-way connection between the tug, the aircraft, and the ground equipment does not exist.
- Connect the ground equipment to the tug.

Following these steps avoids a 3-way connection and it is now safe to drive away.
