# SAFETY ALERT

NUMBERS: SA18-02

## Be Aware of Jet Blast!

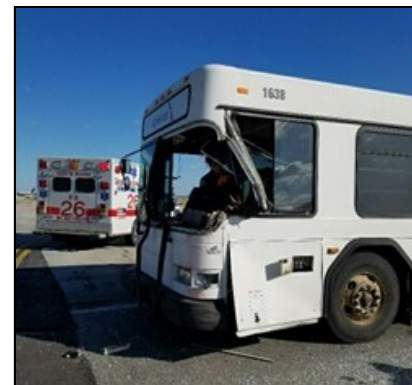
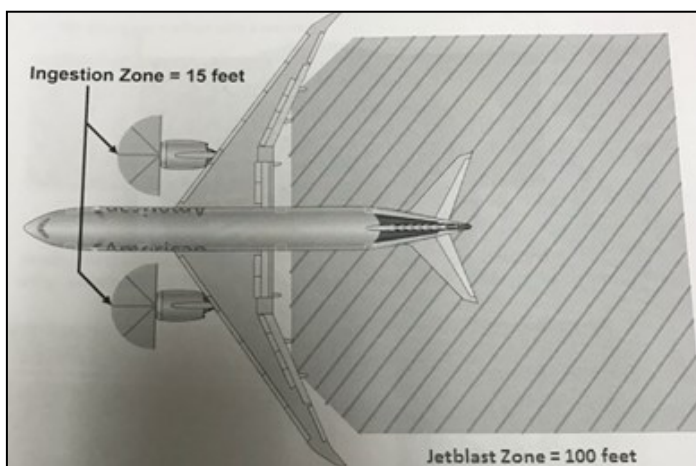
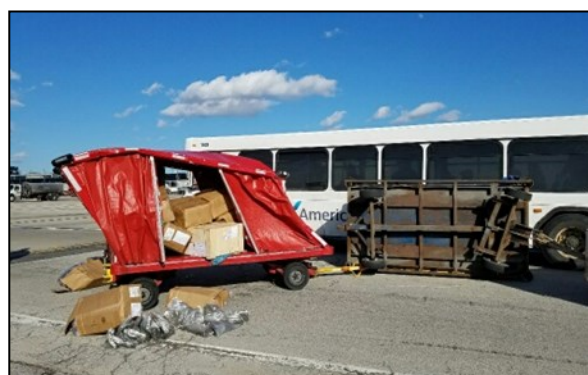
On 2/25/2018, an American Airlines employee bus and carts from an American Airlines air freight vehicle made impact on the service road at the end of G concourse resulting in multiple injuries. Video surveillance shows jetblast from a 777 overturning carts over to the lane the bus was driving on as it was exiting the alpha taxiway to the bravo taxiway.

**NOTE: All employees who operate motor vehicles on service roads in the vicinity of warmup or holding aprons, particularly when crossing taxiways behind jet aircraft, should exercise extreme caution in avoiding the potential hazard caused by aircraft jet blast.**

The Jet blast zone as defined by American Airlines is 100 feet for each aircraft when the engines are at idle. When more throttle is applied to the engines, the jet blast zone increases up to 2100 feet for engines at full throttle. – Ramp Initial Participation Guide
